PITTSBURGH UNIV PA DEPT OF ANTHROPOLOGY  
AN ARCHITECTURAL STUDY OF SOME FOLK STRUCTURES IN THE AREA OF T--ETC(U)  
AUG 62 R C CARLISLE

**An Architectural Study of Some Folk Structures in the Area of the  
Paintsville Lake Dam, Johnson and Morgan Counties, Kentucky**

August 1982

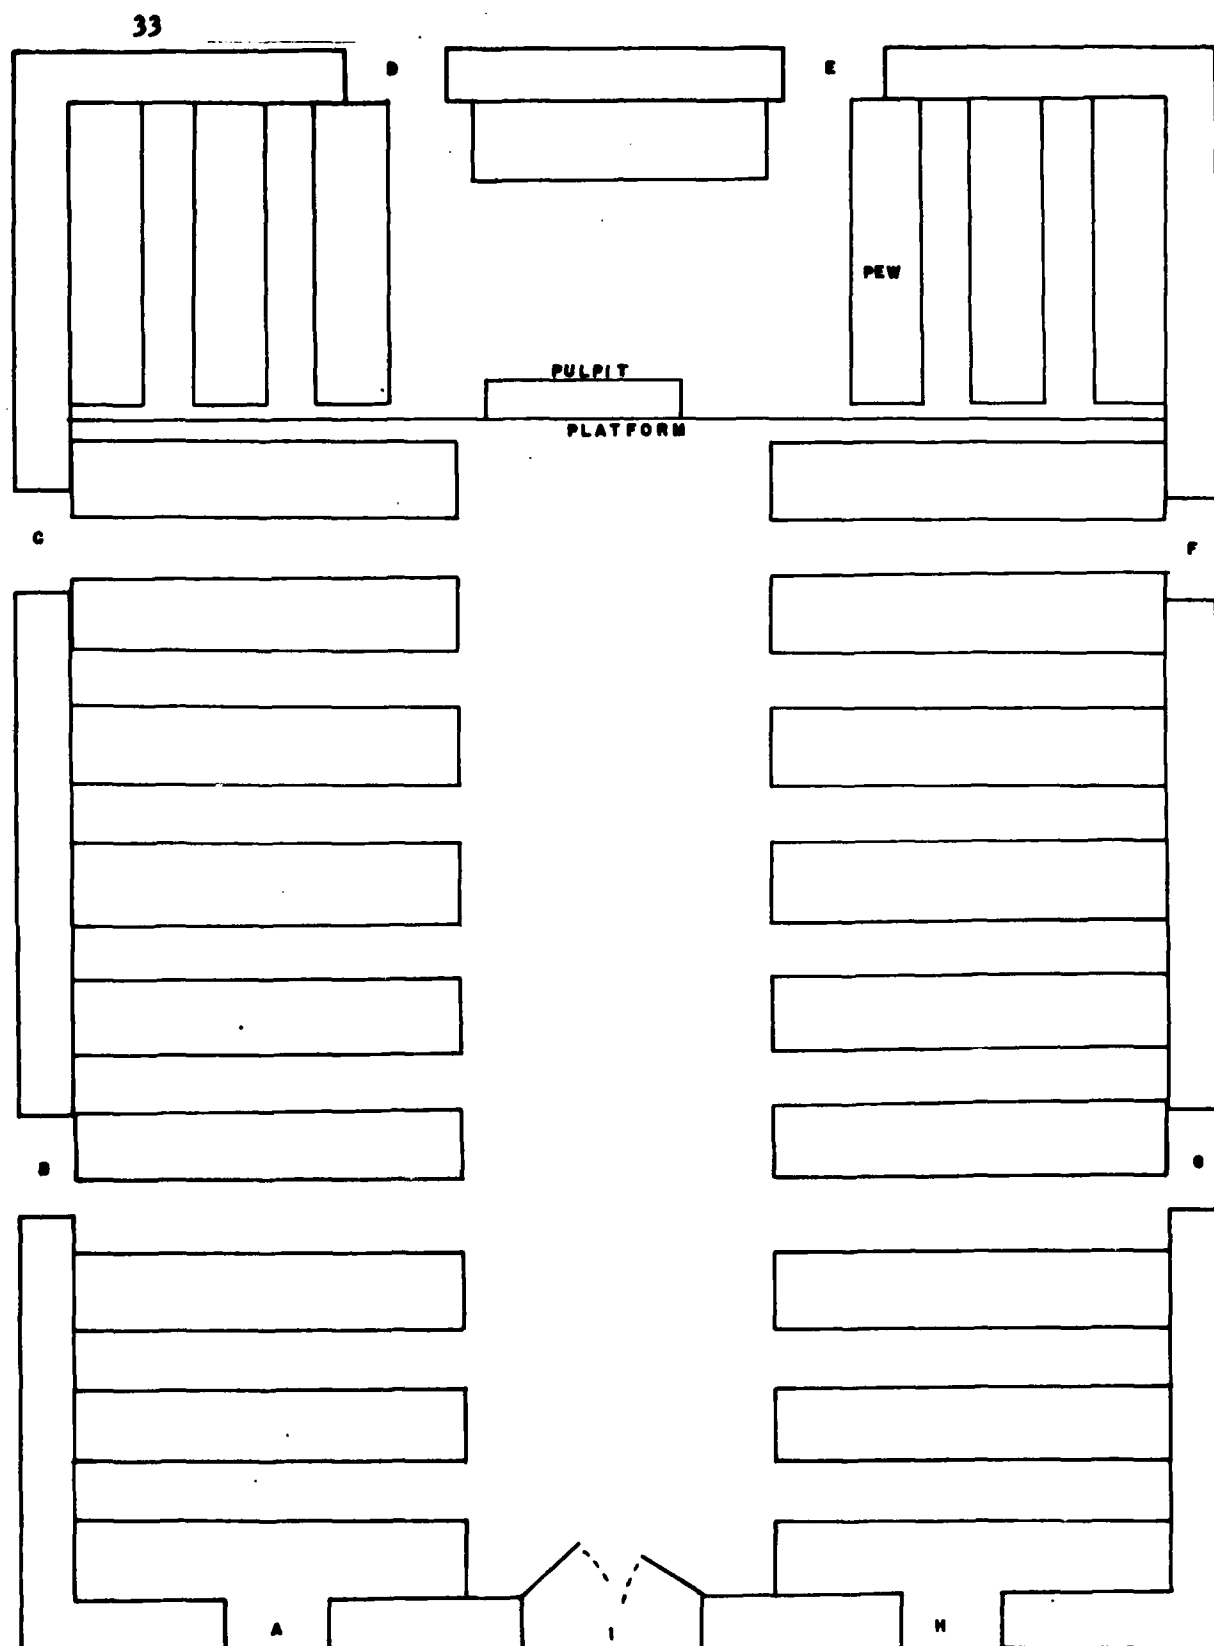
Figure 4. Floor plan of Fishtrap United Baptist Church on Tract 302.

#### INTERIOR ARCHITECTURAL COMMENTS (Figures 4, 15-18).

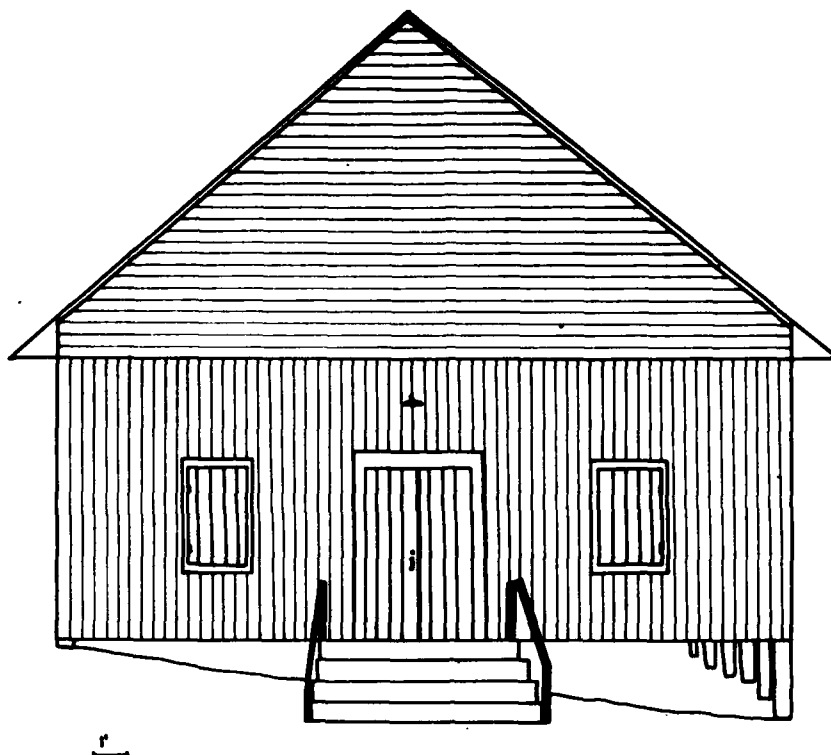
Figure 5. Northwest elevation (front) of the Fishtrap United Baptist Church.

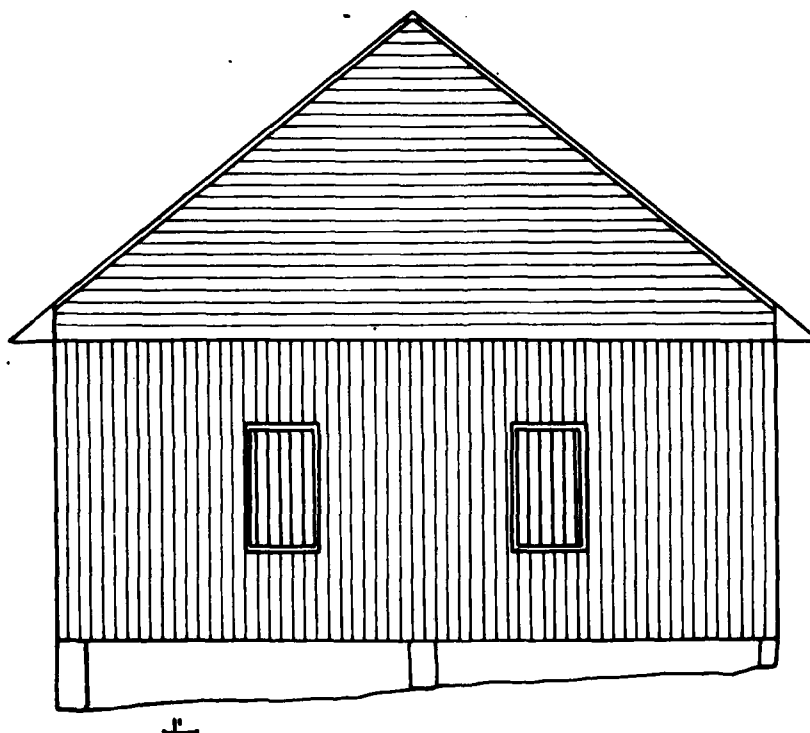
Figure 6. Southeast elevation (rear) of the Fishtrap United Baptist Church.

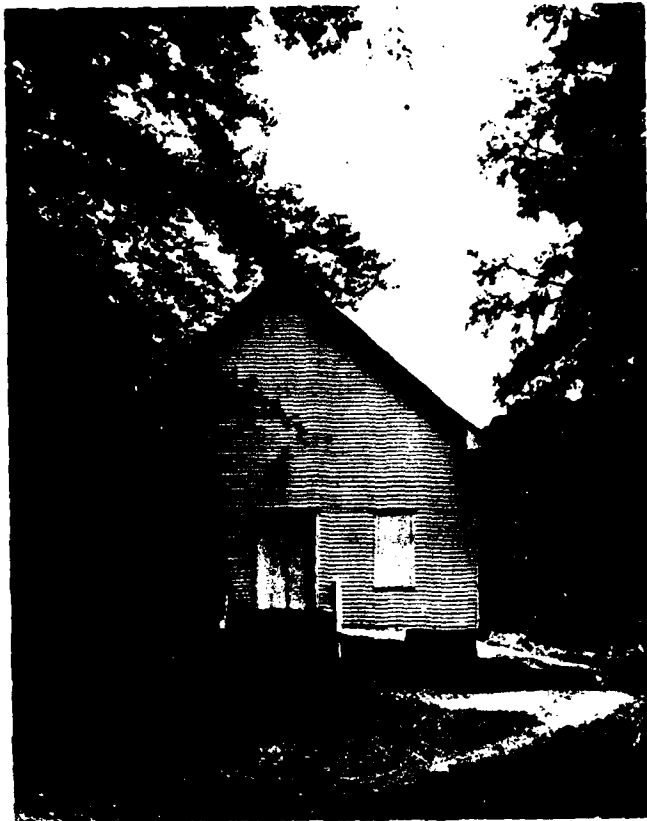
Figure 7. Photograph of the northwest elevation of the Fishtrap United Baptist Church.

Exterior lighting is provided by two single bulb electric gooseneck fixtures; one of these is located on the northwest elevation directly over the entrance to the church (Figure 7). The second light is also centrally positioned in the southeast elevation

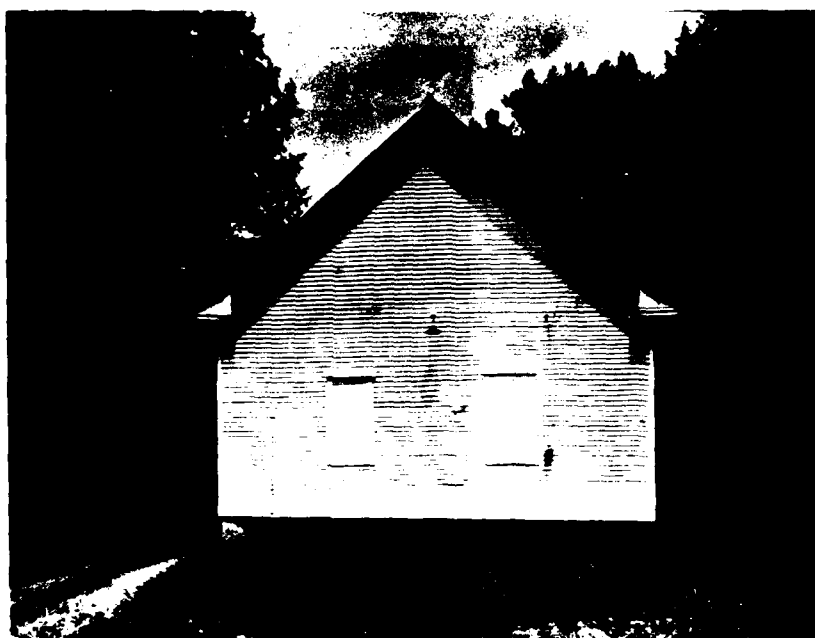
Figure 10. Close-up of the southwest elevation of the Fishtrap United Baptist Church.

between Windows E and F (Figure 10). There is no evidence of any exterior pre-electric lighting devices that may have been employed on the structure.

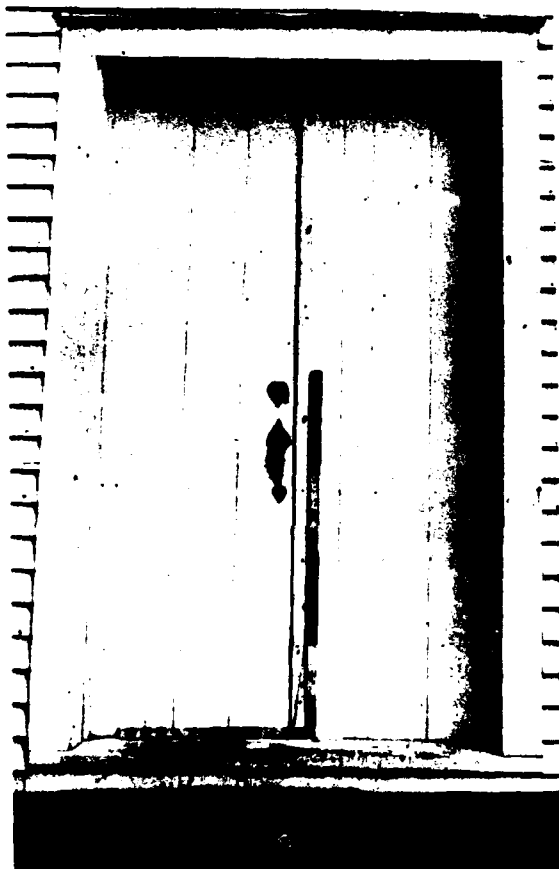
Figure 12. Close-up of board and batten door in northwest elevation of the Fishtrap United Baptist Church. Note modern lock hardware.

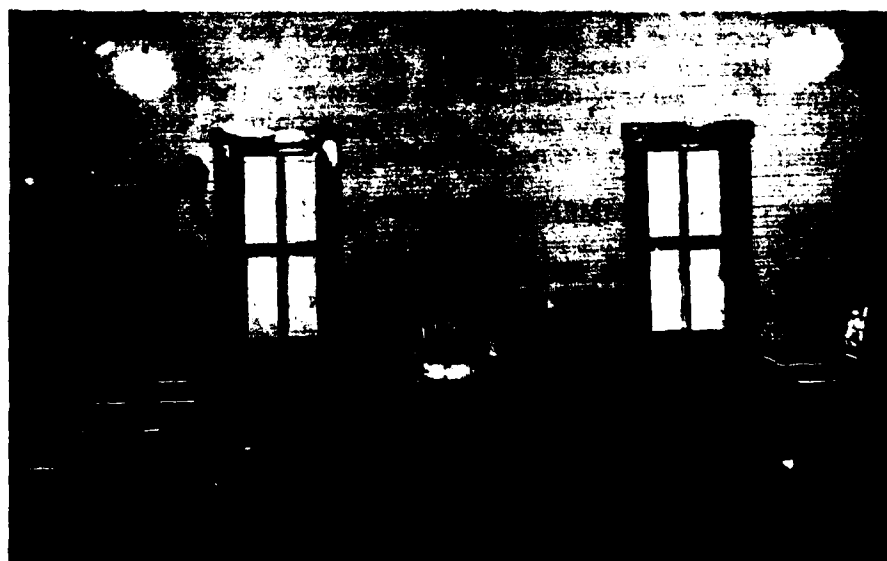
Figure 16. Close-up of altar area of the Fishtrap United Baptist Church.

Entrance through the church's single doorway in the northwest wall leads directly to the sanctuary and the central aisle. At the opposite or southeastern end of the room is a simple wooden altar area (Figures 15, 16) that is raised 7" above the floor. The length of the altar area runs across the width of the room and is itself 7'11" in width. It accommodates two sets of three wooden pews that face each other and are separated by the low wooden pulpit. A solitary pew is placed behind the pulpit. There are a total of nine rows of bench-type straight back wooden pews provided for the congregation on either side of the central aisle (Figure 15). Each congregational pew is 9'11" in length, 1'10" wide and ca. 3' in height. They are spaced at ca. 1'4" intervals. Pews on the altar platform are similar in construction but are 7'10" in length. Pew construction consistently employs milled lumber, but the type of nails used is not available.

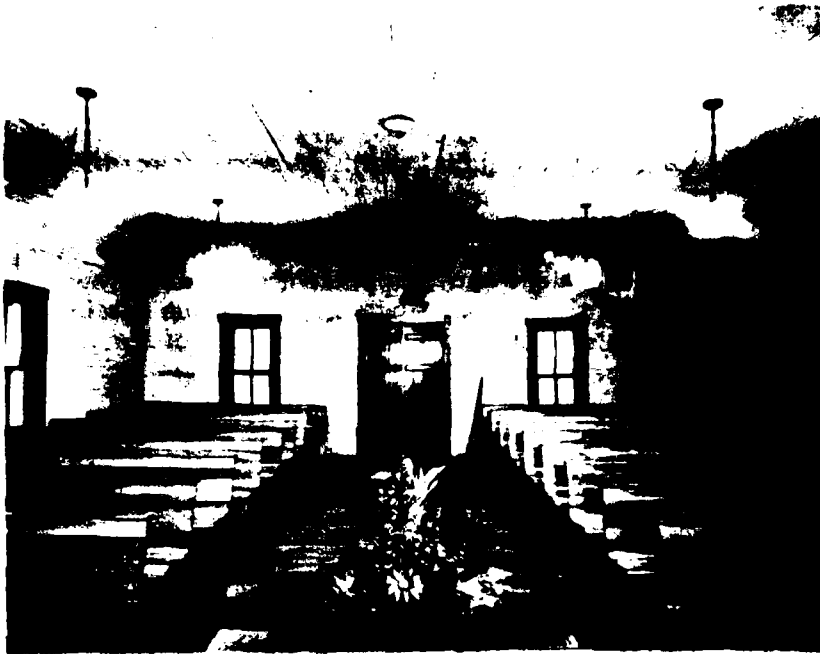
Figure 17. Sanctuary of the Fishtrap United Baptist Church looking toward the structure's solitary door from the altar area.

Near the altar area (see Figures 15, 17) is a metal floor grate used with the gas heating system.

As noted above, the present heating system for the church is a gas-fired suspended furnace located in the north corner of the building (see Figure 17). The previous heating

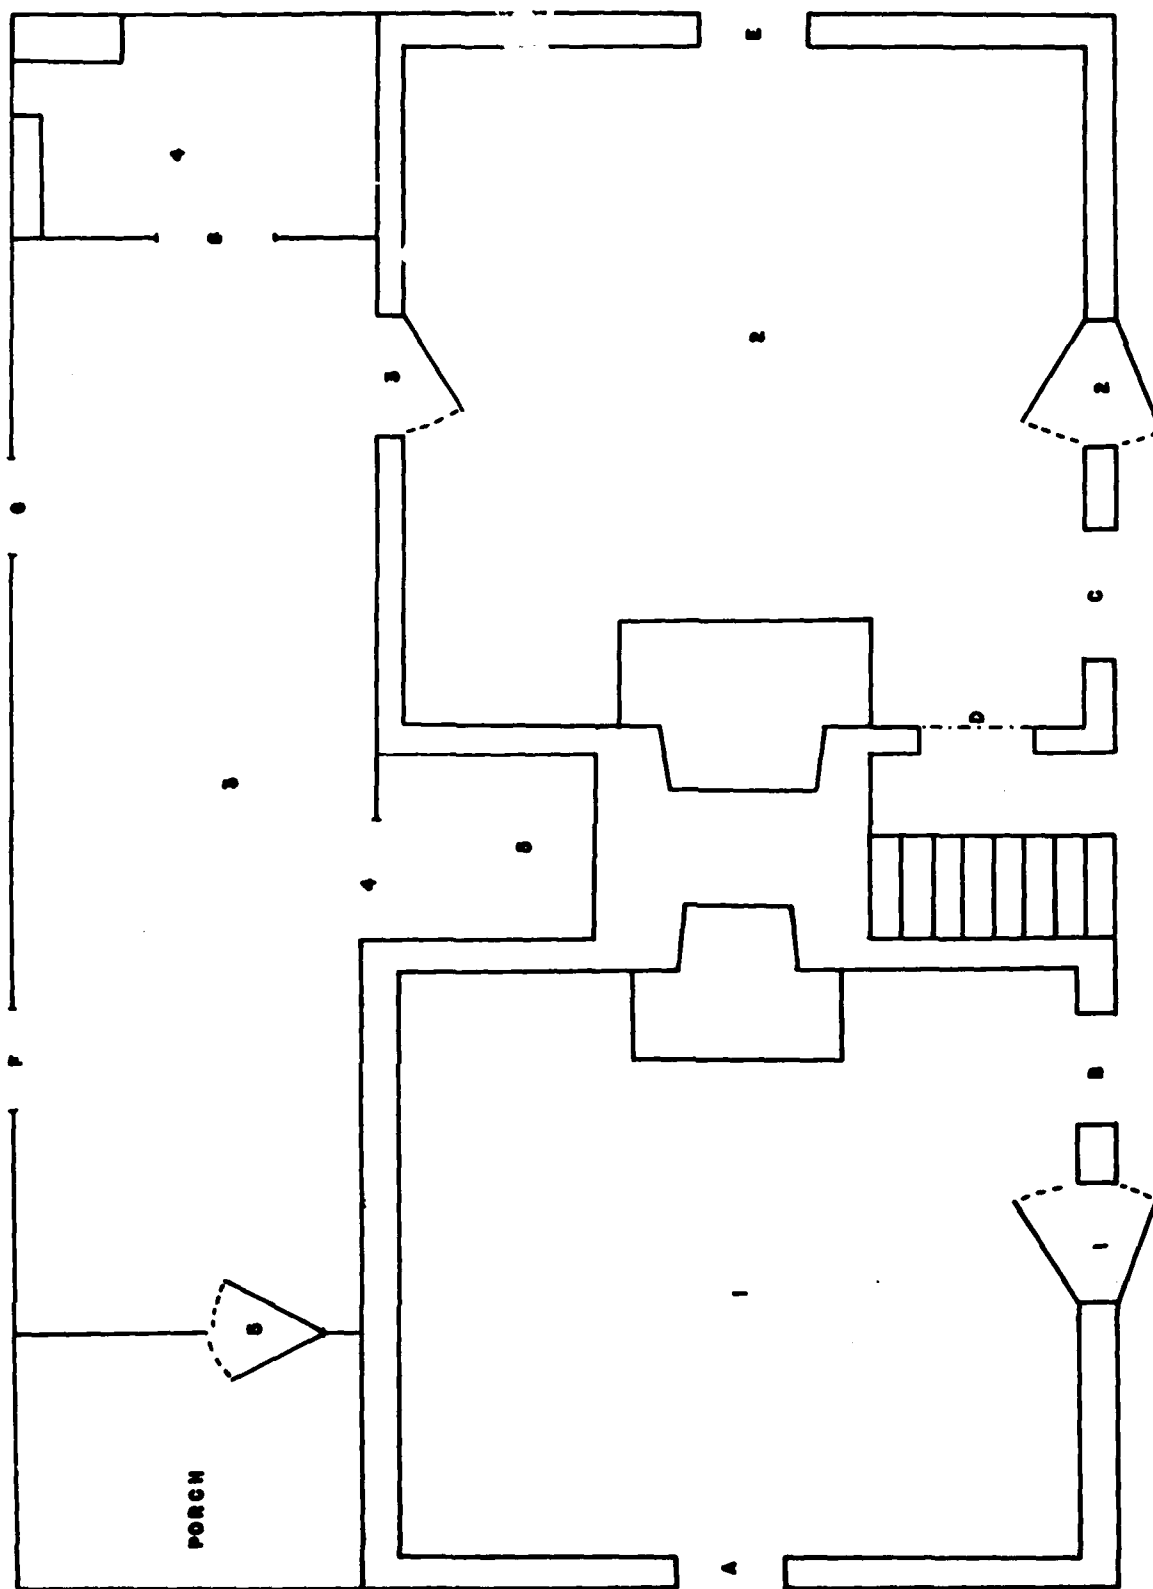
Figure 21. Lower story floor plan of the McKenzie dwelling on Tract 411.

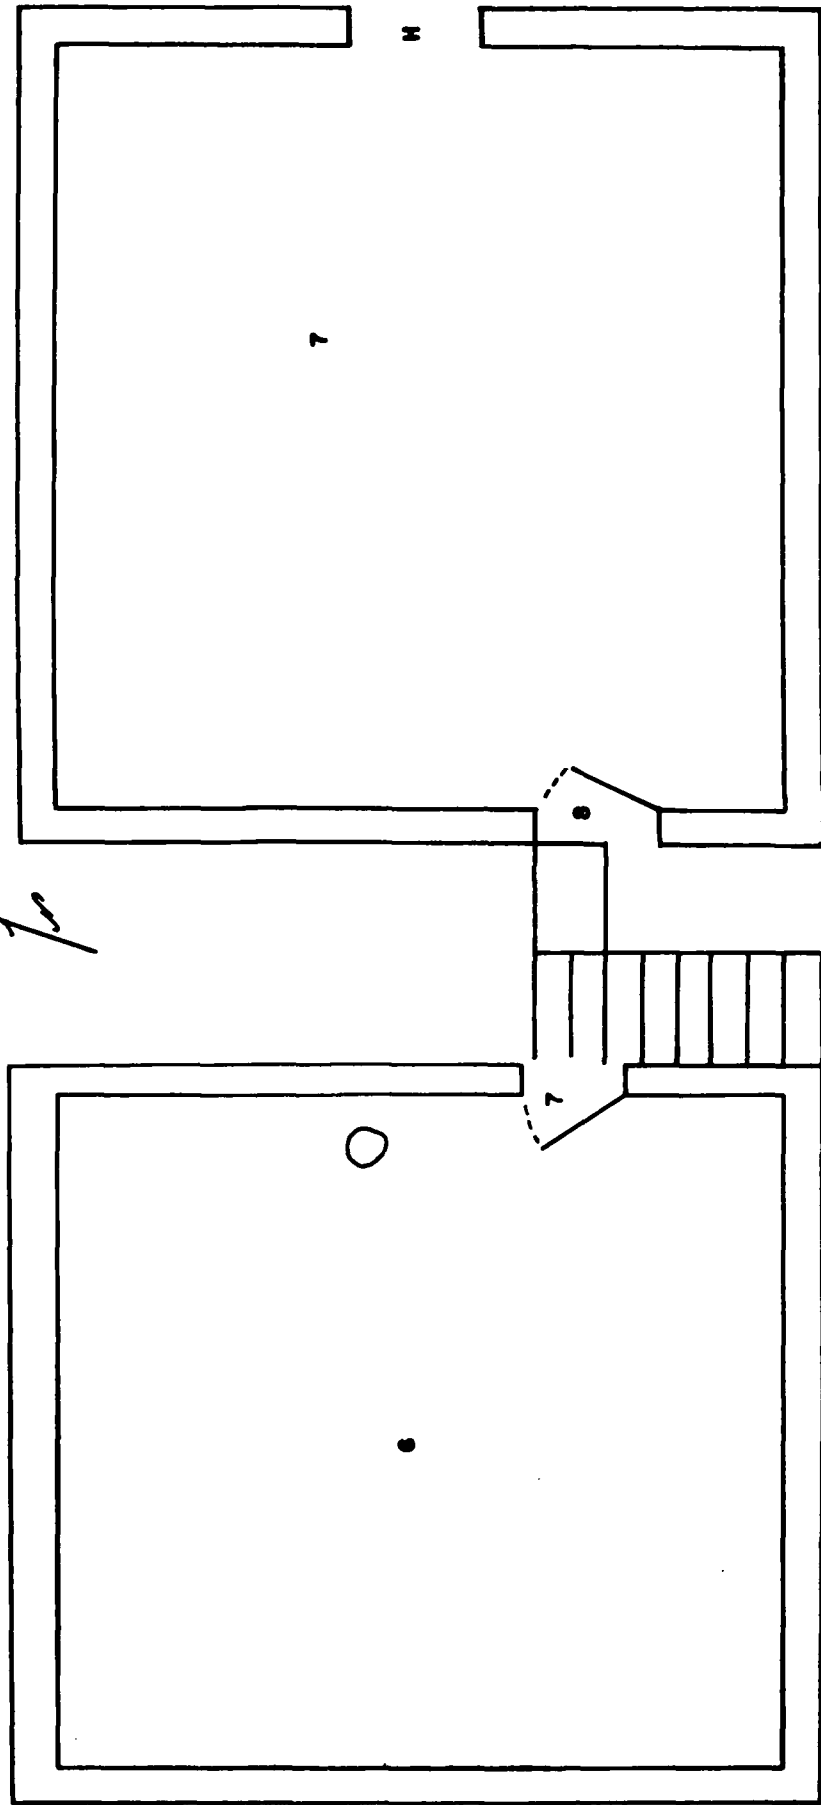
Figure 22. Loft floor plan of the McKenzie dwelling.

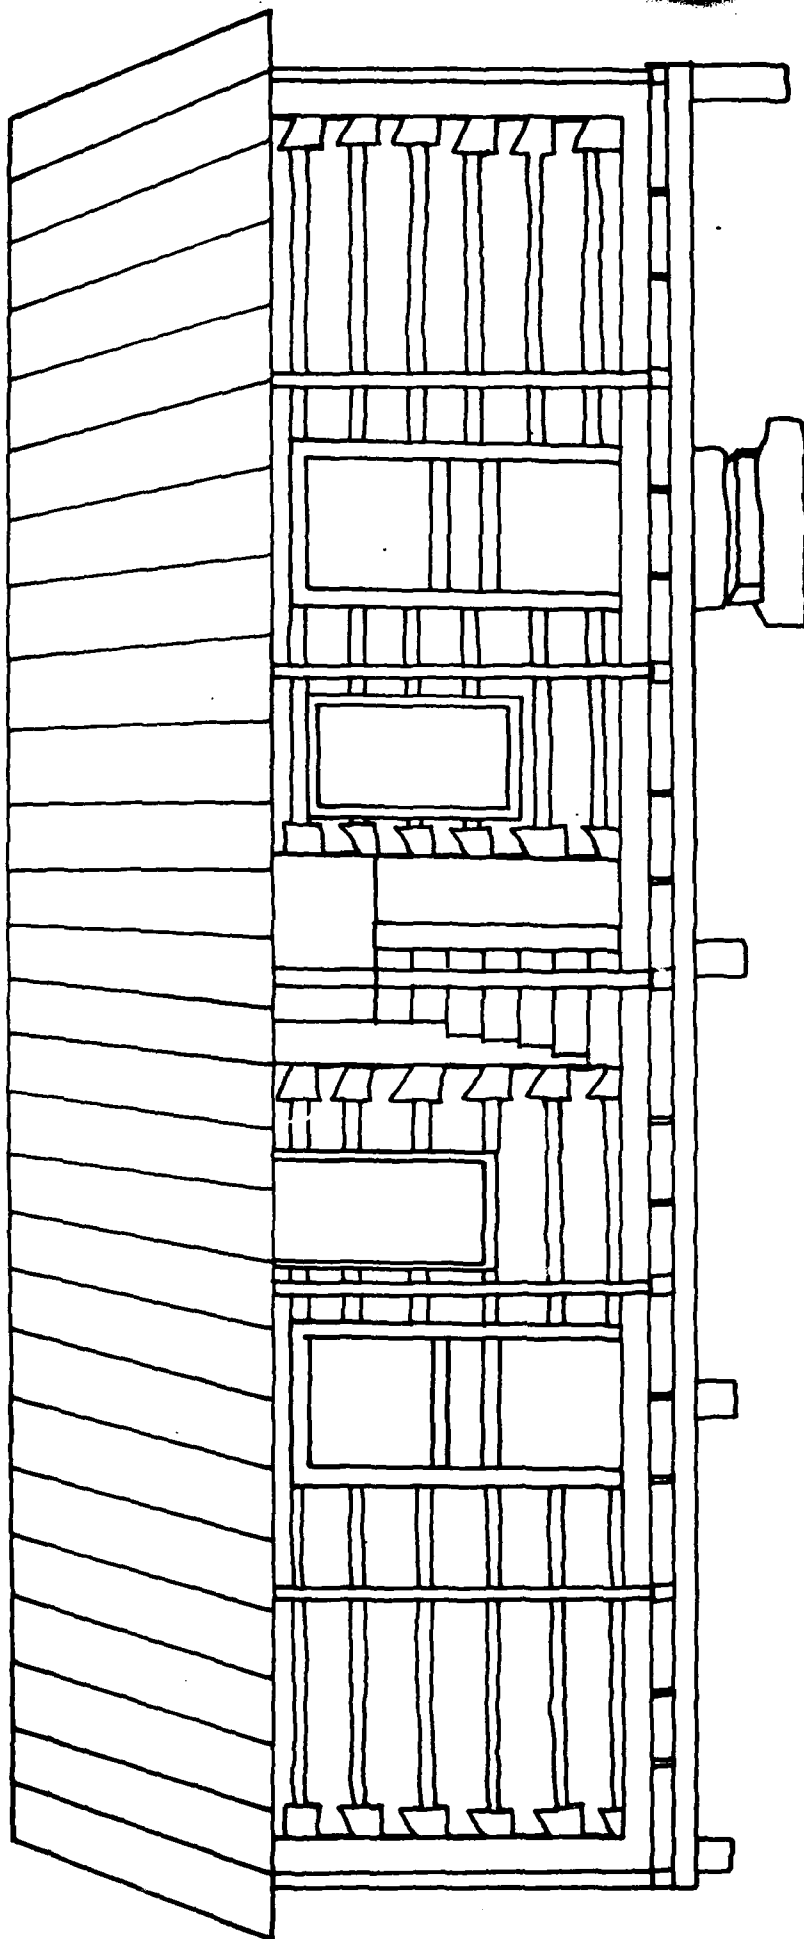
Figure 23. Elevational drawing of south side of the McKenzie dwelling.

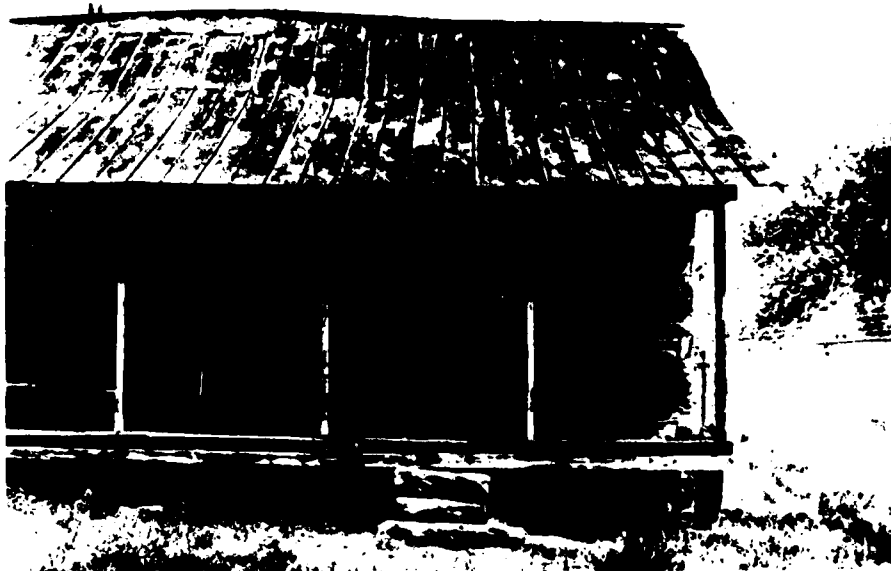
Figure 24. Southern elevation of eastern pen of the McKenzie dwelling.

The dominant feature of the south facade of the structure is the frame construction porch that extends 34'8 1/4" in length (Figures 24, 25). The porch deck is ca. 2'4"-3' above ground level and is supported by four round wooden piers ca. 8" in diameter and 1'4" in height. These piers (probably obtained from telephone poles) are spaced at ca. 9" intervals and rest on sandstone slabs ca. 1'3" square. The porch sill is composed of a 6" high broadaxed beam surmounted by 4" x 1 1/2" milled lumber joists to which the four lengths of 4" wide plank flooring are attached with wire nails (Figure 28). Porch width is approximately 6', while the deck to roof height is 7'2". The porch roof, which itself is an extension of the gable roof of the structure, is supported by a series of seven milled lumber posts, ca. 2 3/4" square and spaced ca. 5'6" apart (Figures 24, 29). At present, the porch is mounted by a single set of sandstone slab steps positioned just in front of Door 2 into the eastern pen (Figures 24, 25). The three sandstone slabs are 2'8" in width and rise ca. 1'11" in total height above ground surface. The present porch on the McKenzie dwelling is not the original one. Everett McKenzie recalled that it was built

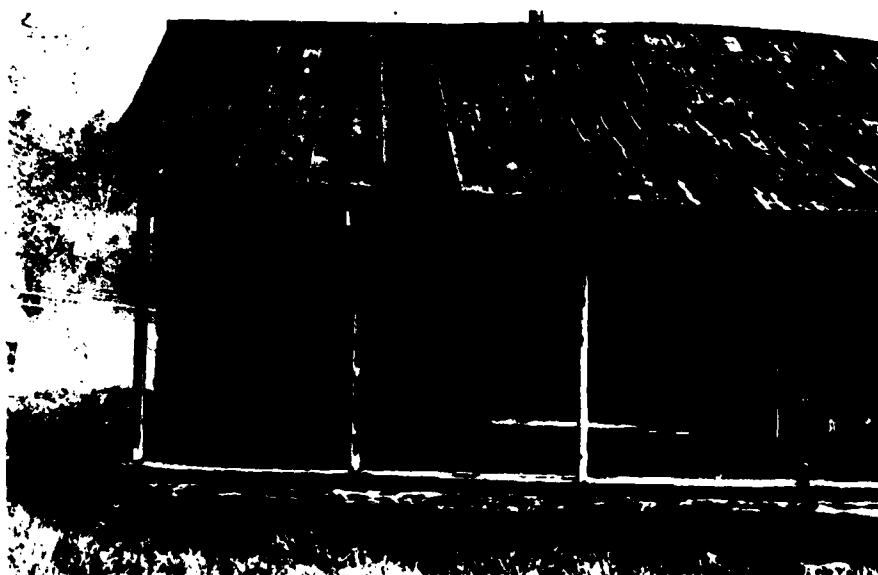
Figure 29. Southern elevation of western pen of the McKenzie dwelling.

The western pen of the structure (Figures 29, 34-40) is composed of logs of yellow pine (*Pinus* sp.). These, too, have been dressed with a broadax on their interior and exterior surfaces and retain their natural convexity on the decorticated superior and inferior faces. There are 10 logs in the northern and southern elevations with nine logs in the eastern and western elevations (Figure 36). The latter rest on a (now) collapsed sandstone wall foundation. The additional log in each wall of the western pen over and above the number found in the eastern pen was necessitated by the generally smaller size of the logs employed in the former. These range from 10" to 1' in height and are ca. 6" in thickness. Half dovetail notching is the predominant corner notching technique employed, but this is not exclusively so; as can be seen in Figure 34, both inverted V and square notching also are used. The 2"-5" interstices between the logs of the western pen also show evidence of mud chinking much of which either had washed out or had crumbled away at the time that the survey was conducted. This second pen is somewhat smaller in overall dimensions than the eastern pen and measures 14'4" across its south wall and 16'4" across its western wall.

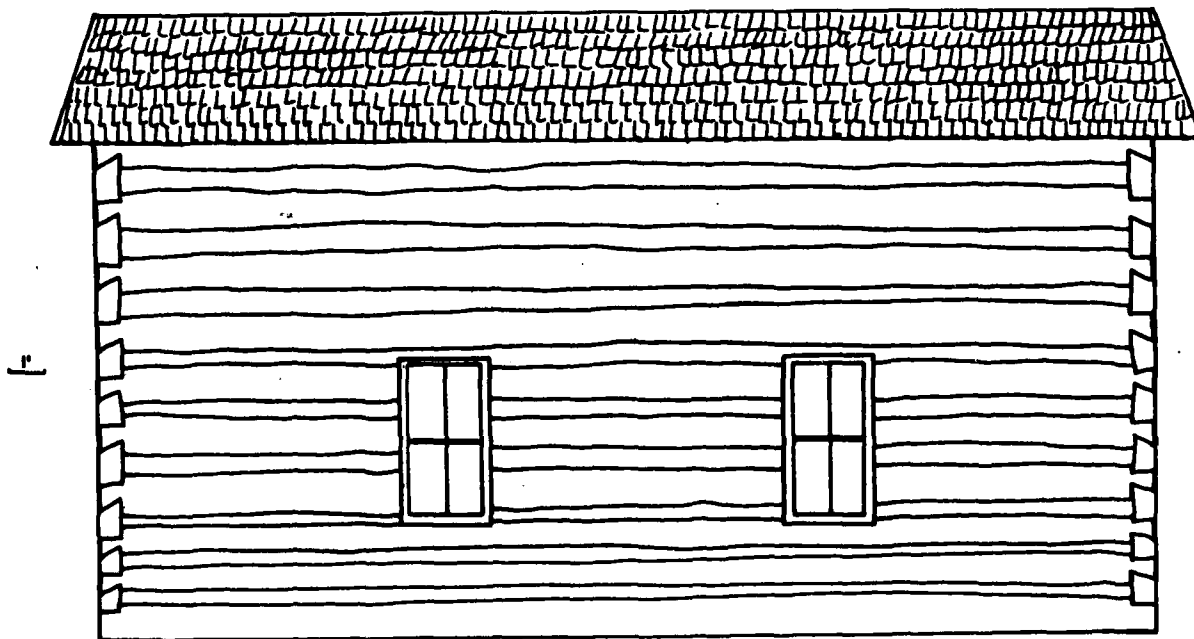
Figure 56. Line drawing of the present northwest elevation of the McKenzie Branch school.

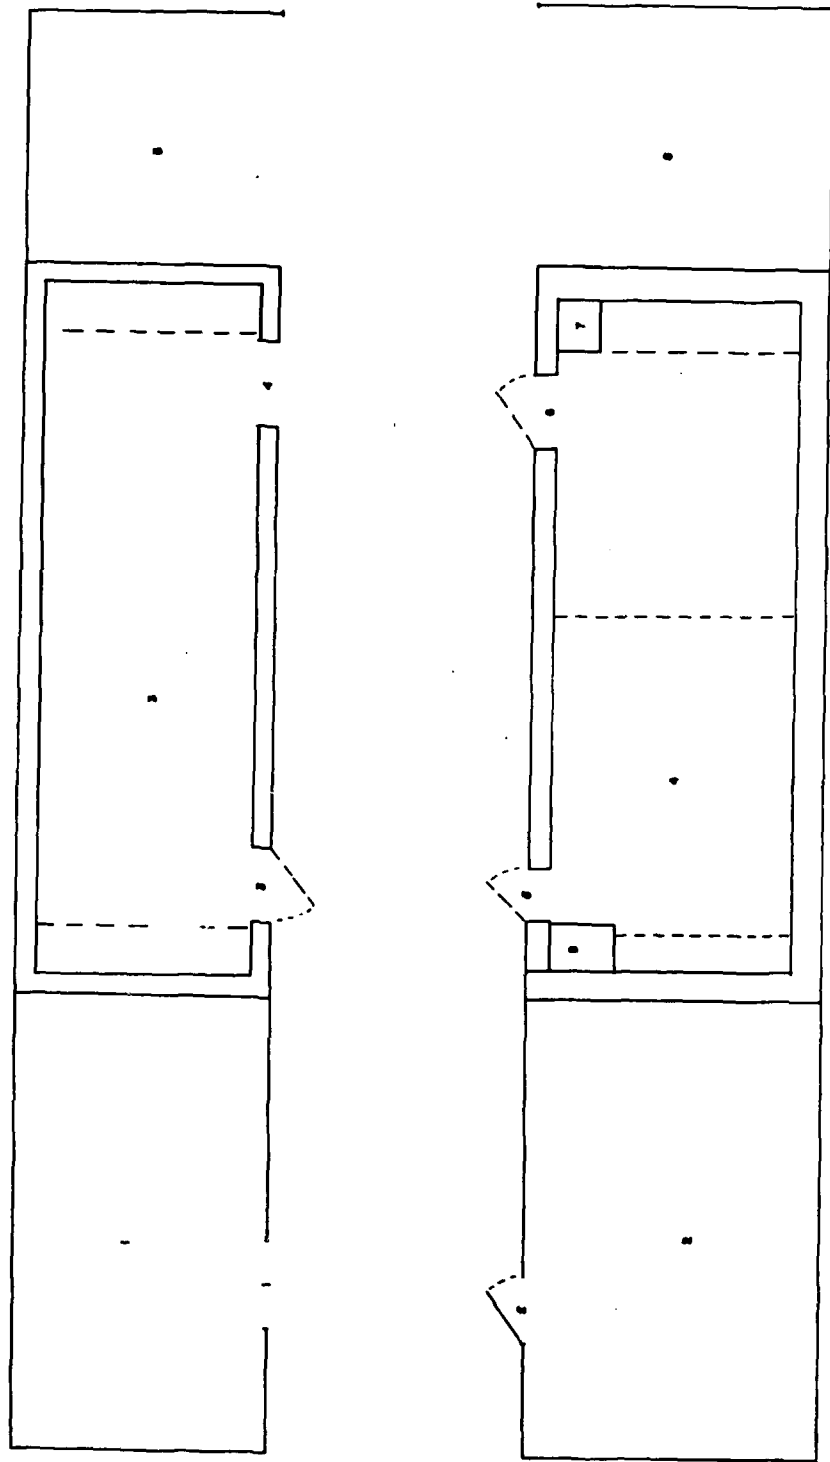
Figure 60. Floor plan of the Mitchell Rowland saddle notched log and frame construction barn on Tract 412.

Attached to the northeast side of the log portion of the barn is a frame construction addition each half of which measures ca. 8'3"-8'6" x 16'3"-16'4" (Figures 60, 61). At the time the government acquired the property in 1974, the barn was covered with vertically applied planking. This gave the barn the overall appearance of a completely frame structure, and it was noted as such in the U.S. Army Corps of Engineers' appraisal. When the initial portion of this survey was conducted in 1978, the frame siding had been stripped from most of the barn, and its actual construction was patently clear.

The interior of the Rowland barn is divided into a minimum of four activity areas. To these must be added the two tobacco curing areas on the southwest side of the structure that are referred to as Activity Areas 5 and 6 respectively in Figure 60.

Activity Area 1 (Figure 60) appears to have been used for general farm storage purposes including hay, crating and tobacco spears. It has a wooden floor elevated 1'2" above ground surface. The floor is composed of 1' wide circular sawed planking ca. 1" in thickness. The flooring parallels the long axis of the barn; it is supported by a log sill and by ca. 2" x 8" circular sawed floor joists. Undecorticated tie beams consist of mixed pine (*Pinus* sp.) and oak (*Quercus* sp.) poles ca. 6" in diameter. Roof rafters are 2" x 4" milled lumber spaced on ca. 2' centers (Figure 61). Access to Activity Area 1 is through a single doorway (see Table 6) off the runway (Figure 60).

Activity Area 3 abuts Activity Area 1 and is one of the two rooms created from the log enclosure (Figure 60). Although now a single room measuring 26' x 8'5" there is evidence that it was once divided into three equal-sized compartments by interior partitions. The two compartments closest to the southwest side of the structure are floored with circular sawed 8"-1' wide planks attached with wire nails. The floor boards are laid across the short axis of each compartment perpendicular to the long axis of the barn. The remaining compartment of Activity Area 3, which is entered through Doorway 3, has a dirt floor.

The function of Activity Area 3 is not known. At the time of the survey, it was used only to store tobacco spears, and neither animal droppings nor crop residues were observed that might suggest specific uses for any of the three compartments in this Activity Area. As can be seen in Figure 60, however, Activity Area 3 contains two feed troughs, one at either end of the room. These are oriented perpendicular to the long axis of the barn and measure ca. 7'3" x 2'8". Assuming that the two end compartments of Activity Area 3 were used to stable animals, the center compartment may have been utilized for fodder storage. Note that entrance to the center compartment must have been through one or both of the end compartments; it could not have been entered directly from the runway. Functionally, this links the center compartment with activities of the end compartments rather than with the activities of the runway.

While animal stabling seems to have been the principal use of Activity Area 4, a quantity of tobacco spears were also noted. Entrance to Activity Area 4 is gained through two doorways (Doorways 5 and 6, see Figure 60). Only Door 6 was present at the time of the survey. Note in Figure 64 that except for three courses of logs that extend the length of the barn (two courses on the opposite side of the runway, the additional course above Activity Area 4 was added to compensate for difference in land slope) and the sill log, the interior log walls do not extend past the first jamb of either doorway. The intervening area between the two doors is enclosed with variable width and length circular sawed planks 1" in thickness spaced at variable intervals and simply nailed to the logs above and below with wire nails. Spacing the boards in this manner undoubtedly improved light and increased the ventilation of the pen.

Activity Areas 5 and 6 (Figure 60) of the Rowland barn share a common shed roof and together comprise an addition to the southwest side of the structure that appears to have been given over to tobacco curing. Each of these areas measures ca. 8'1" x 8'11". Activity Area 5 (Figure 60) contains a plank floor which is not employed in Activity Area 6. Neither area appears to have been enclosed though as noted previously both of them shared a shake shed roof that also extended over the runway that is 9' in width at this end of the barn.

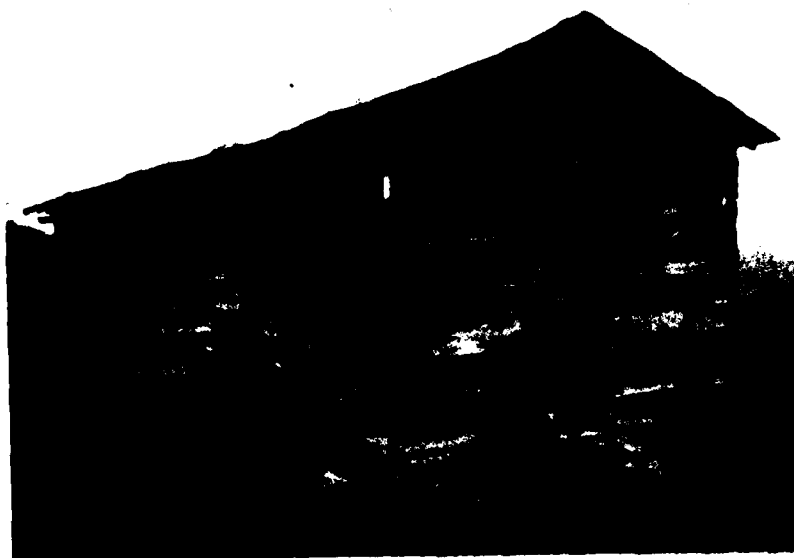
Figure 67. South and west walls of the Jesse Williams dwelling/barn. The eastern wall is raised above the natural slope of the ground by the use of a series of sandstone piers fashioned from fieldstone. Note the use of the weatherboard-enclosed space above the log pens to extend the overall height of the structure. This photograph, provided from U.S. Army Corps of Engineers Real Estate files shows the structure before it was heavily overgrown. Contrast this with Figure 68.

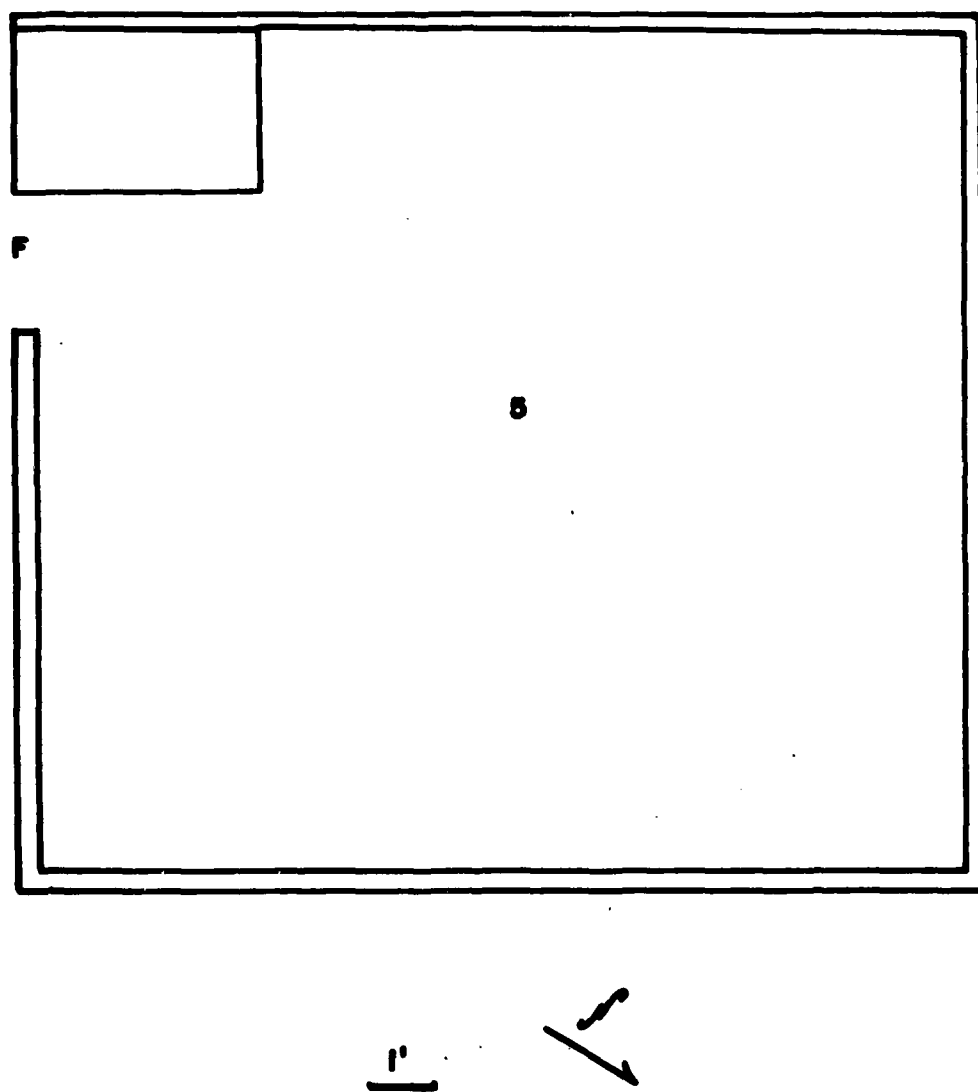
Figure 77. Loft floor plan in log portion of the J. C. Jenkins dwelling.

Room 5, the loft area in the log portion of the dwelling is entered in its south corner by stairs from Room 1 below. As pointed out above, it served as sleeping quarters when the Jenkins family owned the property. Interior room dimensions are 13'2" x 14'8". Floor to ceiling rafter height is 6' while floor to roof peak height is 8'. There is a single window (Window F) in the southeast wall directly adjacent to the stairwell (see Figure 77).

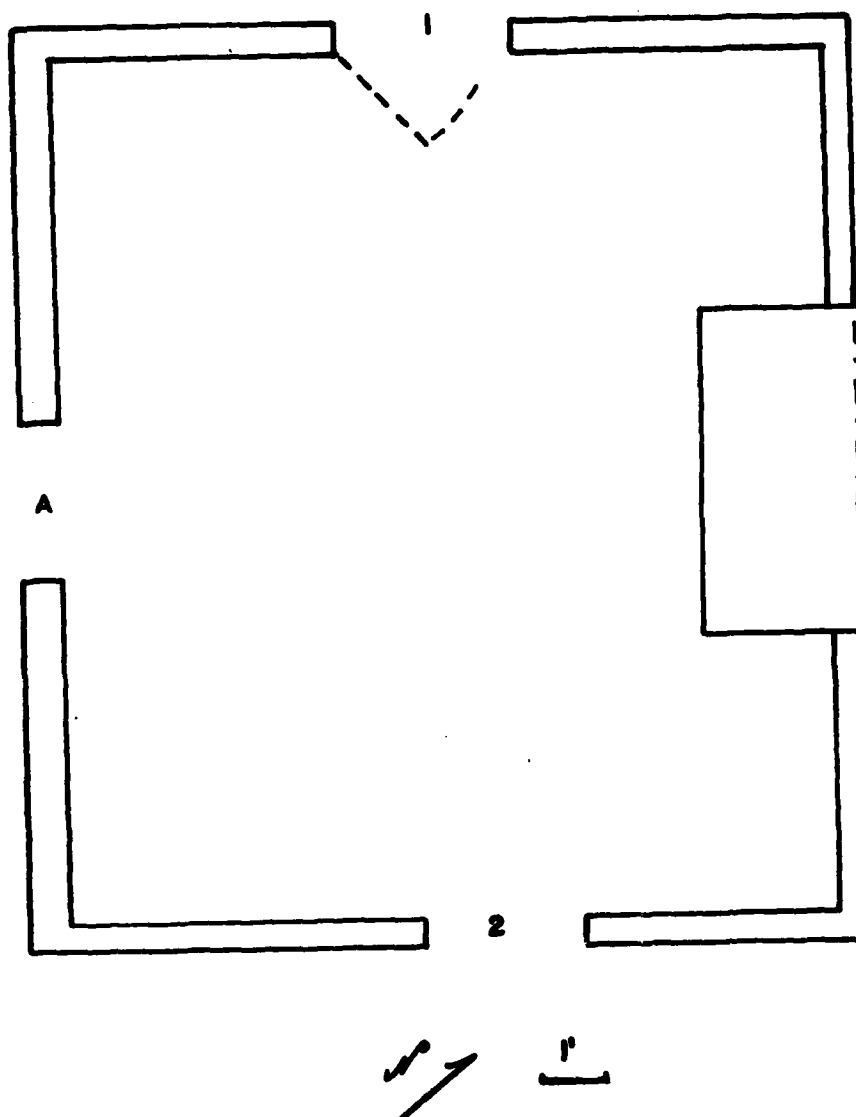
Figure 101. Floor plan of the Jim Gilliam dwelling on Tract 923. Although the property was in the possession of the Gilliam (or Gillam) family for many years, very little is known of the history of the structure.

The structure is a single pen dwelling that is almost perfectly square. Overall exterior length along the northwest elevation is 14'1 1/2", while the southwest elevation measures 14'1 3/4". There is no indication of the previous presence of any frame additions to the structure.

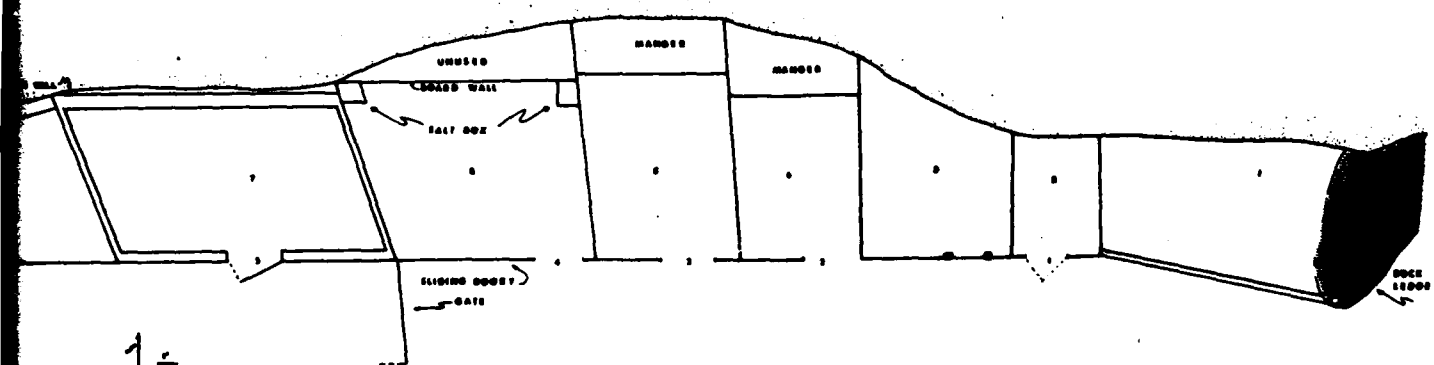
Figure 109. Floor plan of the Jim Gilliam cliff barn on Tract 924.

The open-air Activity Units (Activity Units 1 and 14) are located on either end of this lengthy but narrow building. The morphology of the barn is governed entirely by the massive sandstone overhang that forms a natural but shallow roof over the barn. In several cases, the sandstone floor and wall of the shelter also form the floor and wall of the corresponding barn Activity Unit. A board or plank wall comprises the back (north) wall of other Activity Units (6, 7, 8). Some units (5, 7, 8) have raised wooden floors, and two of these (7, 8) may have been used for storing grain or other perishables that require a dry floor.
